CHAPTER FOUR - PARKS AND RECREATION ASSESSMENT

4.1 PARK AND FACILITY ASSESSMENT

Fair Oaks Recreation and Park District

Master Plan for Parks, Facilities and Recreation Services

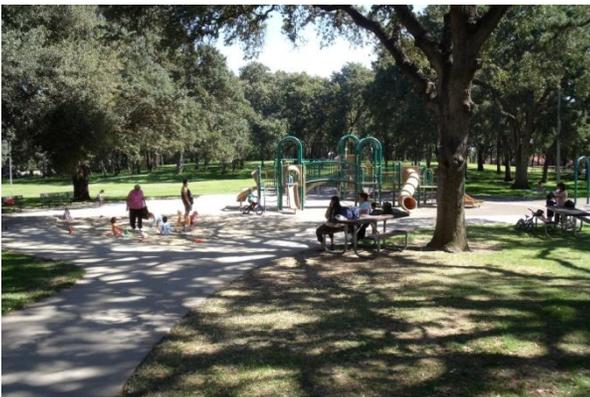
Figure 50 - Play Area at Fair Oaks Park with Mature Trees

including Fair Oaks Park with its mature abundance of trees, community gardens; horticultural center operated in conjunction with UC Davis/not-for-profit agencies and well maintained assets (Figure 50 and Figure 51). Other notable examples include the tennis courts at Miller Park. They are a good fit within the site, are well maintained and provide a quality asset to the community (Figure 52).

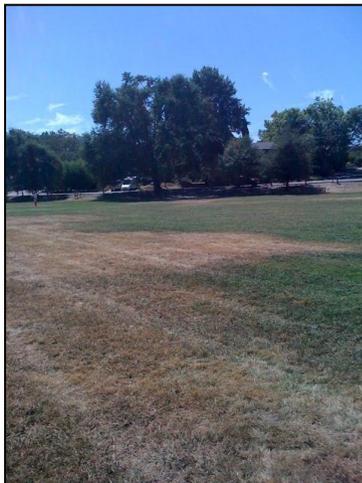
Figure 53 - Bannister Park Multipurpose Field 2

PROS Team conducted assessments of sixteen (16) sports fields, being both ball diamond and multipurpose fields. The PROS Team found many are in good condition, and are well maintained. However, some sports fields do show the need for rebuilding from use (such as the multipurpose fields at Bannister Park (Figure 53)).

Design and maintenance standards should include a design schematic utilized throughout the park including benches and trash receptacles. Also, the multipurpose fields are in need of over-seeding (**Figure 53**).

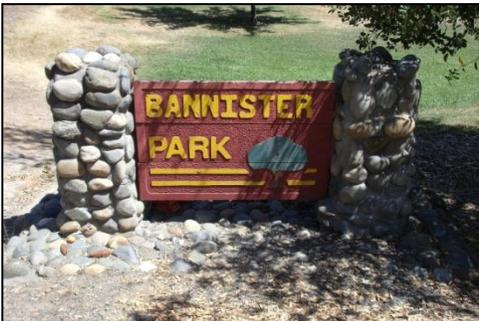
Figure 54 - Bannister Park

Bannister Park is 9.95 acre park functioning as both a neighborhood park and a special use park (being a gateway to the American River). The District has attempted to contain the usage solely to that of a neighborhood park at the request of the surrounding neighborhoods. The goal is to decrease the amount of neighborhood parking, limiting parking lot hours and requiring time-specific parking permits (available to sports field users only). Even with the attempts, it is noted that the existing 55 space parking lot is below

- Major Assets
 - 2 small multipurpose fields
 - 1 outdoor exercise area
 - 1 restroom building with men’s and women’s facilities
 - 1,279 feet of hard surface trail
- Design and Maintenance Standard Recommendations
 - Implement a brand, coloration and design standard for benches and signs
 - Over-seed the multipurpose fields

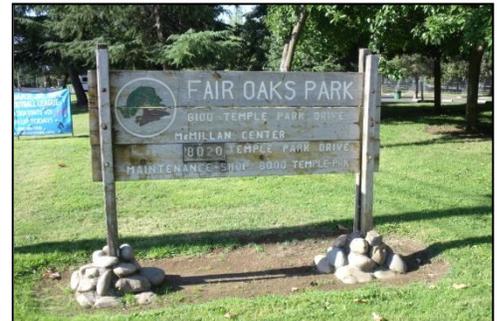
Figure 55 - Fair Oaks Park

Fair Oaks Park is a 29.52 acre park functioning as a community park. The park itself has mature trees and has a picturesque setting. The park includes the McMillan Center and a District Maintenance Facility. The McMillan Center is a small facility measuring approximately 773 square feet of reservable space and includes a fenced courtyard. The facility itself is updated internally but does have potential for an external update. The District Maintenance Facility is unsightly in this park.

However there is potential to relocate the facility or screen it better from view. Also, this facility is perched atop the highest and most visual setting in the park, which could serve as an ideal setting for signature community or recreation center.

- Major Assets
 - 2 large softball diamond fields – skinned
 - 1 large multipurpose field
 - 1.5 basketball courts
 - 1 multi-court
 - 2 horseshoe pits
 - 1 play area
 - 1 community garden area
 - 1 horticulture center
 - 2 restroom buildings with men’s and women’s facilities
 - 1 skate park
 - 2 group picnic areas
 - 1,419 feet of soft surface trail
 - 3,443 feet of hard surface trail
- Design and Maintenance Standard Recommendations
 - Restriping the parking areas
 - Better markings at entrances
 - Adding regulatory and directional signage
 - Implement a brand, coloration and design standard for benches, tables, and signs

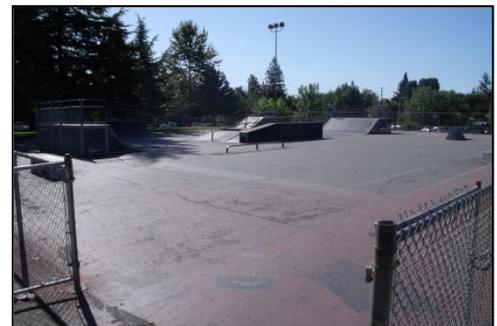
Figure 56 - Skate Park at Fair Oaks Park

The softball fields located at Fair Oaks Park are in good condition and maintained well. However, the paths leading to the ball diamond field areas have potential to be upgraded to a hard surface. Beyond the diamond fields, are the community gardens and the horticultural center. The community gardens and horticultural center are both great assets to this site and are in a well maintained manner. There has been community support for additional community gardens, which could be explored around the skate park facility. The skate park itself is ill suited for this site and has potential to be relocated to a designed site (**Figure 56**).

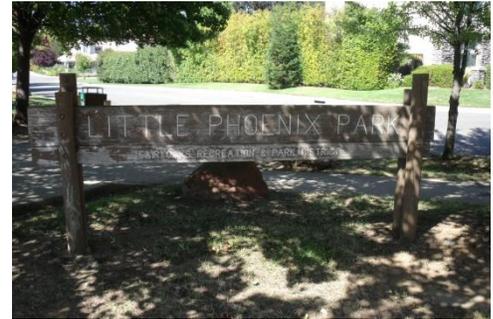
Figure 57 - Little Phoenix Park

Maintenance at the site is adequate, though there is potential for implementation of a brand, coloration, and design standard throughout.

- Major Assets
 - 1 Play Area
 - 455 feet of hard surface trails
- Design and Maintenance Standard Recommendations
 - Implement a brand, coloration and design standard

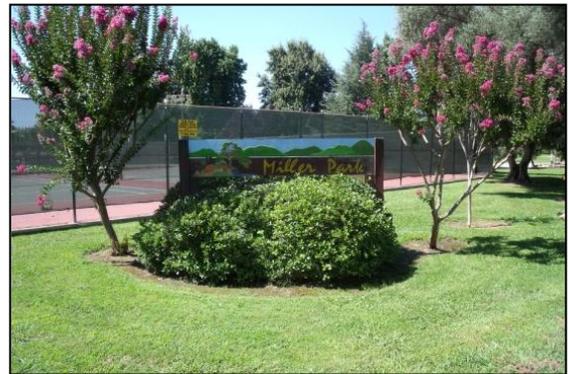
Figure 58 - Miller Park

Miller Park is a 9.27 acre park functioning as a community park. The park serves as the tennis facility for the District, as well as a good park setting. The tennis courts are in good condition with adequate signage and adequate ancillary facilities. The park includes a restroom, drinking fountains and a small picnic pavilion area. The remainder of the park serves as picnic areas and connectivity of neighborhoods, as many people were observed traveling through the site.

There is potential for additional development at the site in the areas around the cellular towers (behind the tennis courts). This area could be developed into a reservable group picnic area or large reservable pavilion (**Figure 59**). Drug and alcohol use has been prevalent in this area and could be eradicated by developing the area. Additional trails should be explored in this area and also around the group picnic area to the play area. Further potential would be to renovate or remove the horseshoe pit area, which is beyond its

- Major Assets
 - 1 basketball court
 - 1 group picnic area
 - 2 horseshoe pits
 - 1 picnic pavilion
 - 1 play area
 - 1 restroom building with men’s and women’s facilities
 - 934 feet of soft surface trails
 - 2,434 feet of hard surface trails
 - 8 tennis courts
 - 2 practice walls
- Design and Maintenance Standard Recommendations
 - Implement a brand, coloration and design standard
 - Renovate or remove the horseshoe pits
 - Fix drainage issues

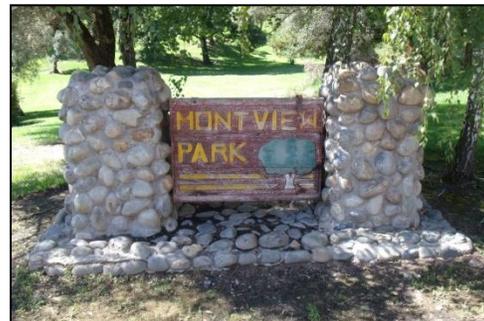
Figure 60 - Montview Park

Montview Park is a 5.14 acre park, functioning as a neighborhood park that is essentially a floodplain or drainage swale area surrounded by neighborhoods. The park has a trail connecting the areas, a play area, a restroom building, several picnic tables, and a drinking apparatus. The overall feel of the park is open and scenic, with good visibility throughout.

Maintenance at the park is needed on the drinking fountain (as it is not functional) and to the roof of the restroom (**Figure 61**). Otherwise, the park is in good condition. Potential at the park includes; developing reservable pavilions or additional picnic pad sites in shade areas as many of the existing picnic tables have been displaced elsewhere throughout the park. There are safety concerns in the park as “ice-blocking” or “watersliding” down the embankments has occurred as well as four-wheel drive vehicles entering the park. These have created the potential to explore monitoring options.

- 1 play area
- 852 feet of hard surface trails
- Design and Maintenance Standard Recommendations
 - Implement a brand, coloration and design standard for benches, tables and signage
 - Repair the drinking fountain
 - Repair restroom roof

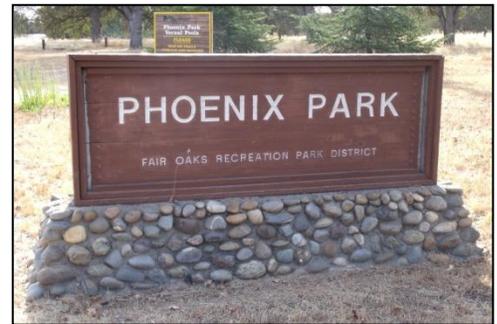
Figure 62 - Phoenix Park

Phoenix Park is a 61.95 acre park that functions as a community park. The park is home to the Vernal Pools which is a good natural outdoor exploration area that is criss-crossed with soft surface trails, good signage and many points of external access. The park overall is disjointed, with many assets scattered around and typically not well connected. The dog park in the back of the park is new and in overall good condition (although there were some drainage issues on the open areas and near the water taps (**Figure 63**)). Many of the multipurpose field surfaces were “clumpy” and should be considered for re-grading.

Potential at the park includes the creation of a master plan to address the location of the assets. Also, there is a need to explore screening or relocation of the VFW building and ingress and egress to the community gardens. Furthermore there is a need to review existing trails and connectivity within the park (as flow is asset driven and not connectivity driven). Lastly there is a potential to create a large reservable pavilion and shade sails around the concessions stand at the ball diamond fields. Maintenance at the park is overall good, although a few drainage issues exist. Design standards should be created for amenities.

- 2 play areas
- 2 restroom buildings with men’s and women’s facilities
- 3 large multipurpose fields
- 3 small multipurpose fields
- 4,772 feet of soft surface trails
- 6,679 feet of hard surface trails
- Vernal Pools Area
- Design and Maintenance Standard Recommendations
 - Implement a brand, coloration and design standard for benches, tables and signage
 - Resolve drainage issues
 - Re-grade multipurpose fields

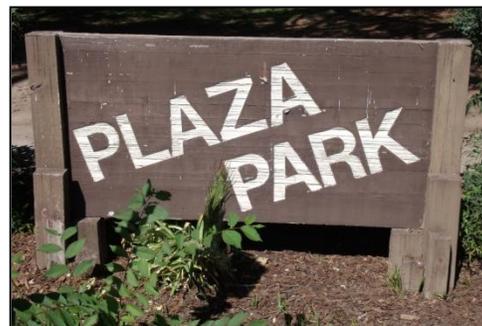
Figure 64 - Plaza Park

Individually, Plaza Park is an open multi-use area surrounded by sidewalks with a large amphitheater for stage productions. There is potential to add an electrical system to better support large festivals. Also, potential exists in the design of the park, with a need for additional trees and trails.

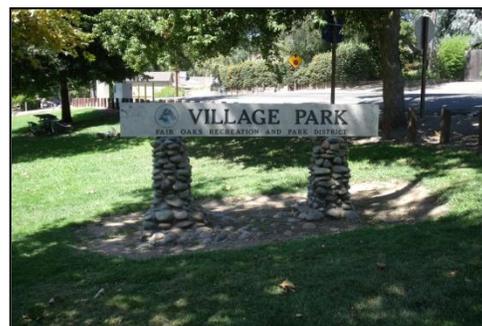
Figure 65 - Village Park

Village Park is a small neighborhood park with a good playground, a band stage and a connecting trail. There are several buildings on the site serving as community meeting rooms and instructional areas. Maintenance issues exist on site as drainage issues were observed as well as a non-functioning drinking apparatus.

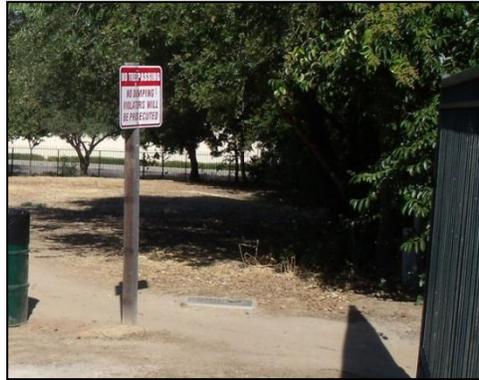
Figure 66 - No Trespassing Sign at Vintage Woods Park

Vintage Woods Park is a 0.44 acre park that serves as a mini park. The park is a connector park between an existing neighborhood and a grocery store with trail and young trees. There is potential for a play area, small pavilion or picnic areas. Also, development of additional trails would increase functionality. Maintenance at the park is adequate, although signage needs improvement (**Figure 66**).

- Major Assets
 - 45 feet soft surface trails
 - 330 feet hard surface trails
- Design and Maintenance Standard Recommendations
 - Implement a brand, coloration and design standard
 - Improve signage within the park (No Identification Sign and No Trespassing Sign)

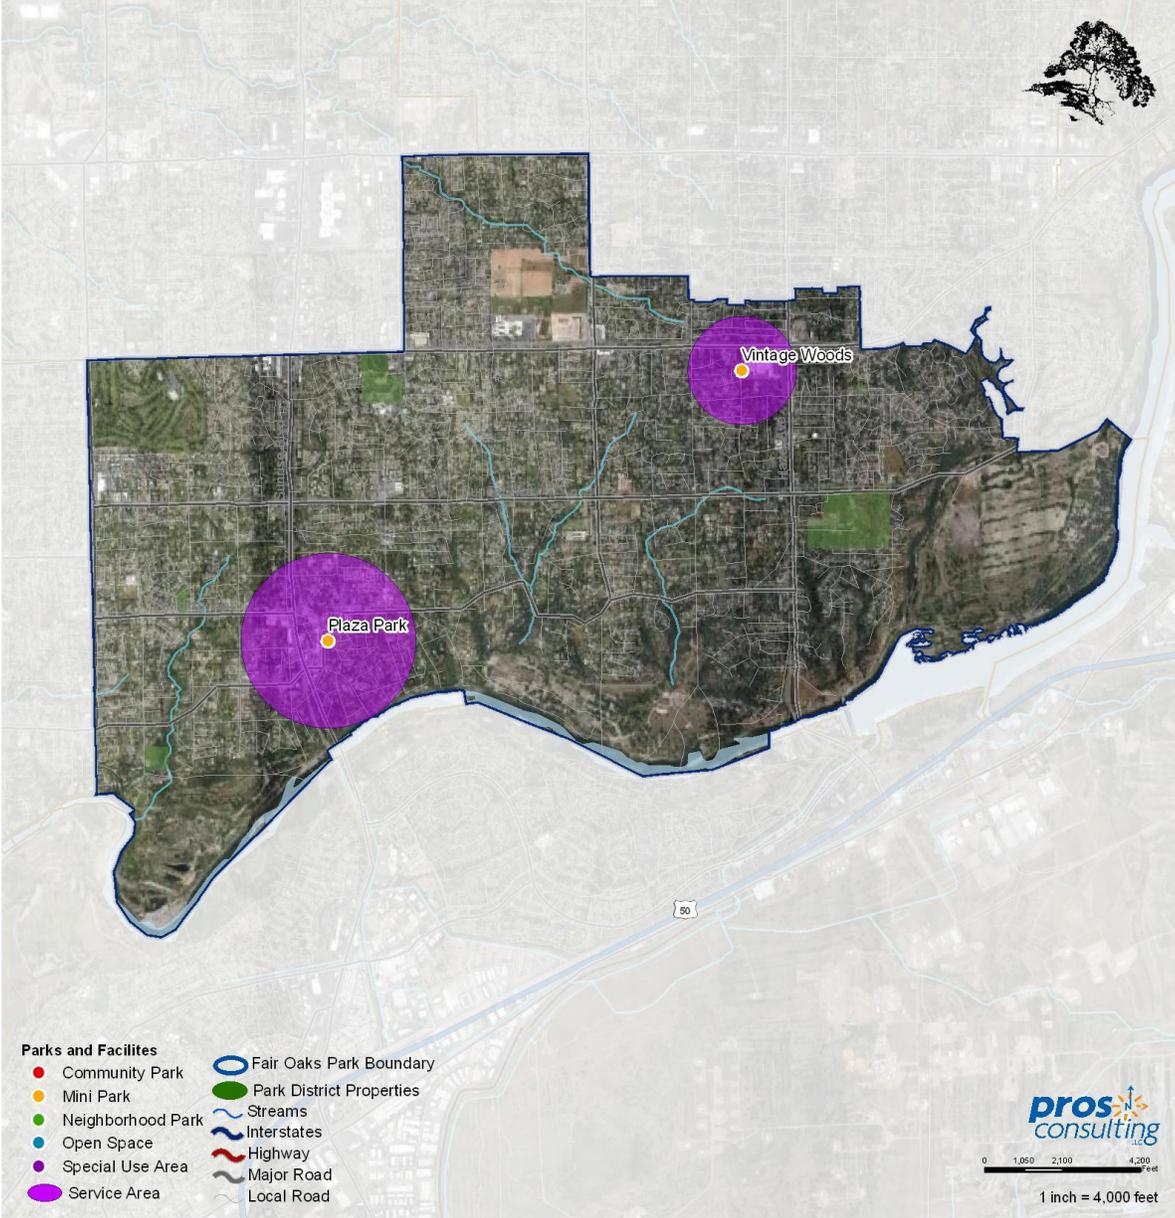
Figure 68 - Mini Parks Service Areas

Figure 68 demonstrates the location of mini parks in the Fair Oaks service area and the associated population densities. The District has 1.51 acres of mini parks. This correlates to a current service level for mini parks of .05 acres per 1,000 people. This map shows the recommended service level of .50 acres per 1,000 people. The District does not meet the recommended standard. To meet the standard, the District needs to add 13.00 acres of mini parks and to meet the projected 2019 standards, an additional 1.000 acre for a total of 14.00 acres of mini parks. There is currently a need for service in the majority of the District as the existing parks are in the north central region of the District.

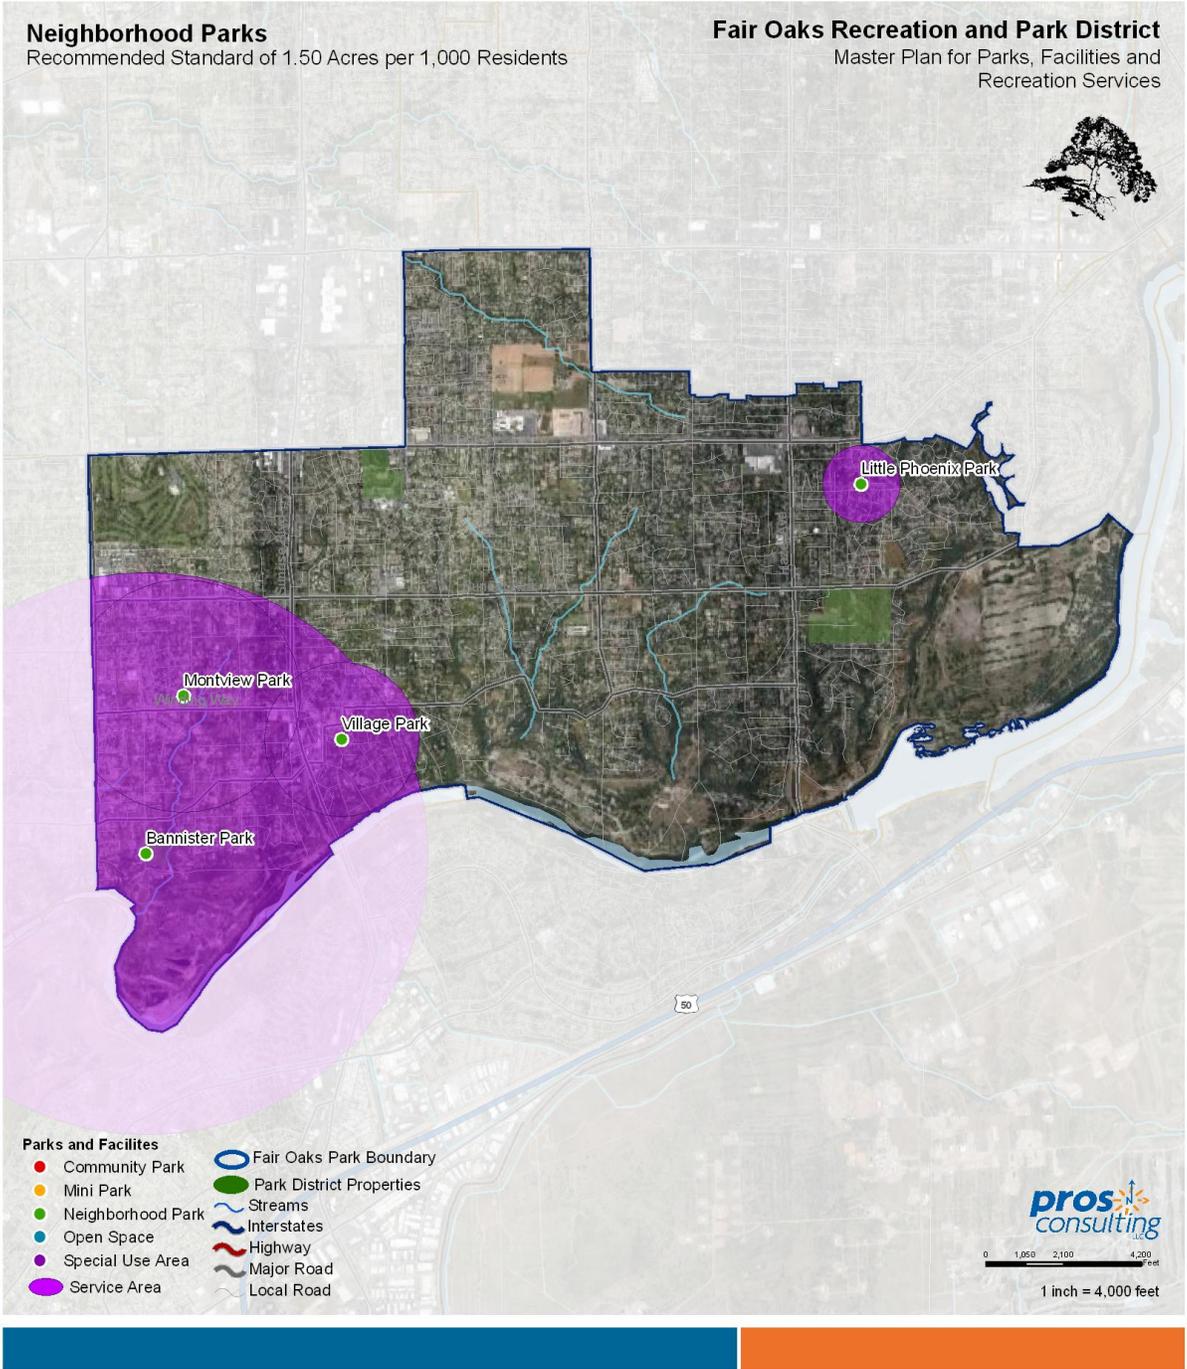
Figure 69 - Neighborhood Parks Service Area

Figure 69 demonstrates the locations of the neighborhood parks in the Fair Oaks service area and the associated population densities. The District has a total of 18.43 acres of neighborhood parks. This correlates to a current service level of 0.64 acres per 1,000 people. This map shows the recommended service level of 1.50 acres per 1,000 people. The District does not meet the recommended standard. To meet the 2009 recommended standard, the District will need to add 25.00 acres of neighborhood parks and 2.00 additional acres to serve the projected 2019 population, for a cumulative total of 27.00 additional acres. Currently there is a need for service in the majority of the District with the current coverage being predominantly in the southwestern corner of the District.

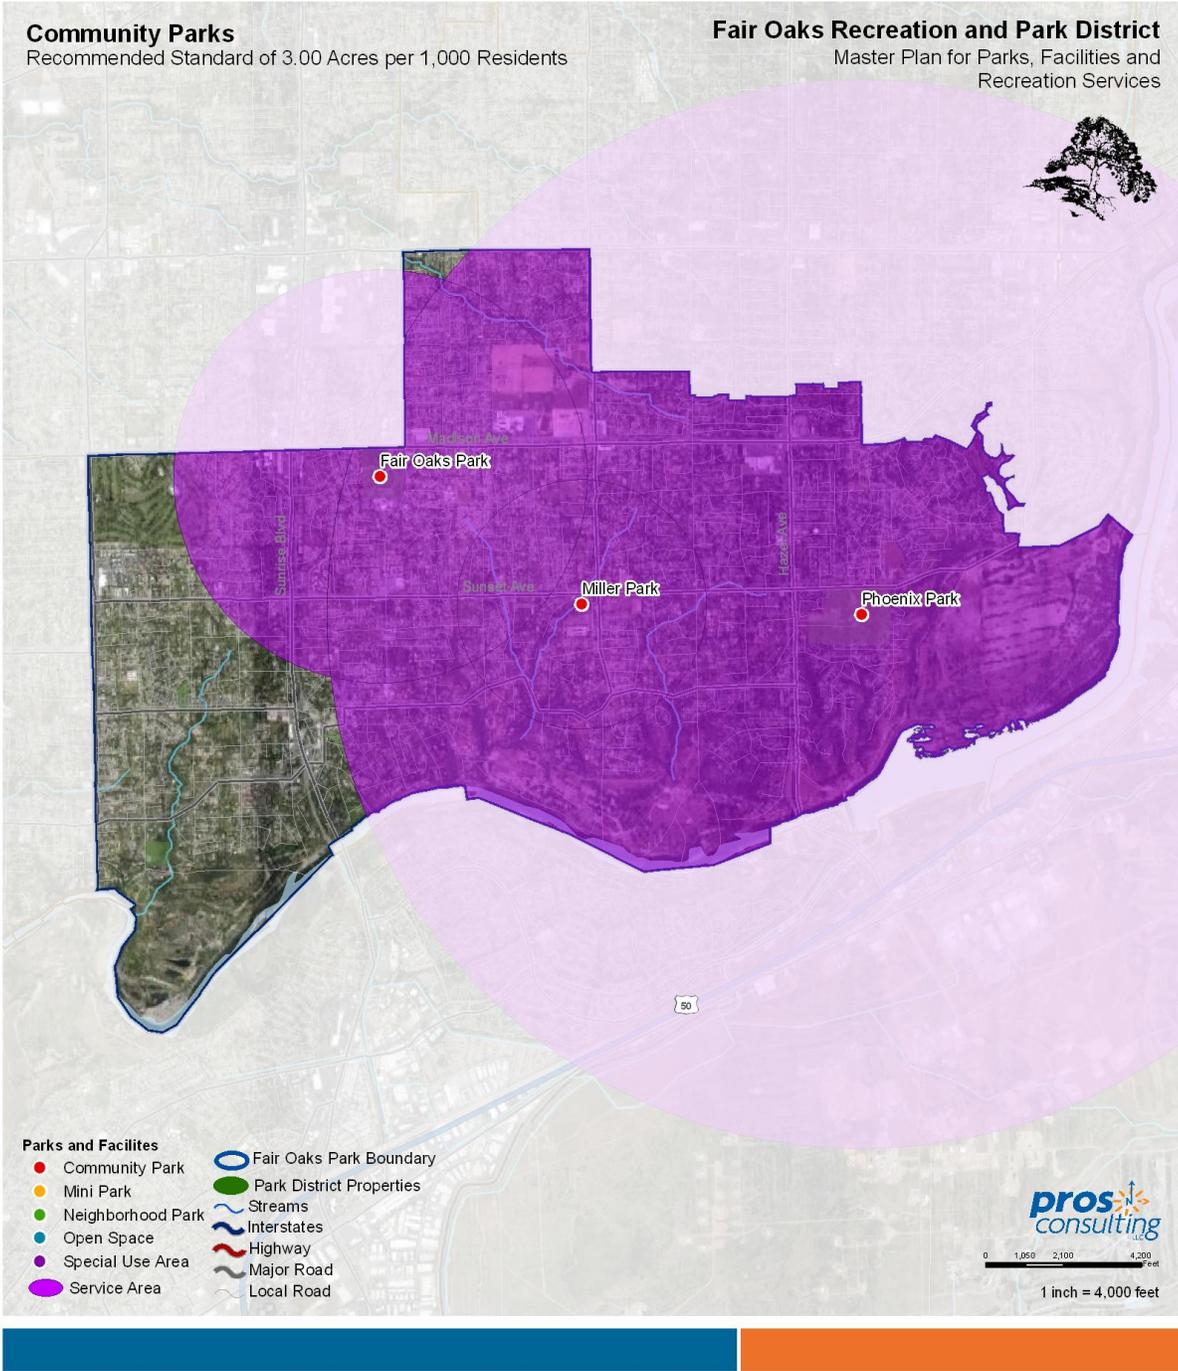
Figure 70 - Community Parks Service Area

Figure 70 demonstrates the location of community parks in the Fair Oaks service area and the associated population densities. The District has 100.74 acres of community parks. This correlates to a current service level for community parks of 3.48 acres per 1,000 people. This map shows the recommended service level of 3.00 acres per 1,000 people. The District currently meets the recommended standard and will continue to do so to serve the projected 2019 population. Currently there is a need for service in the westernmost region of the District.

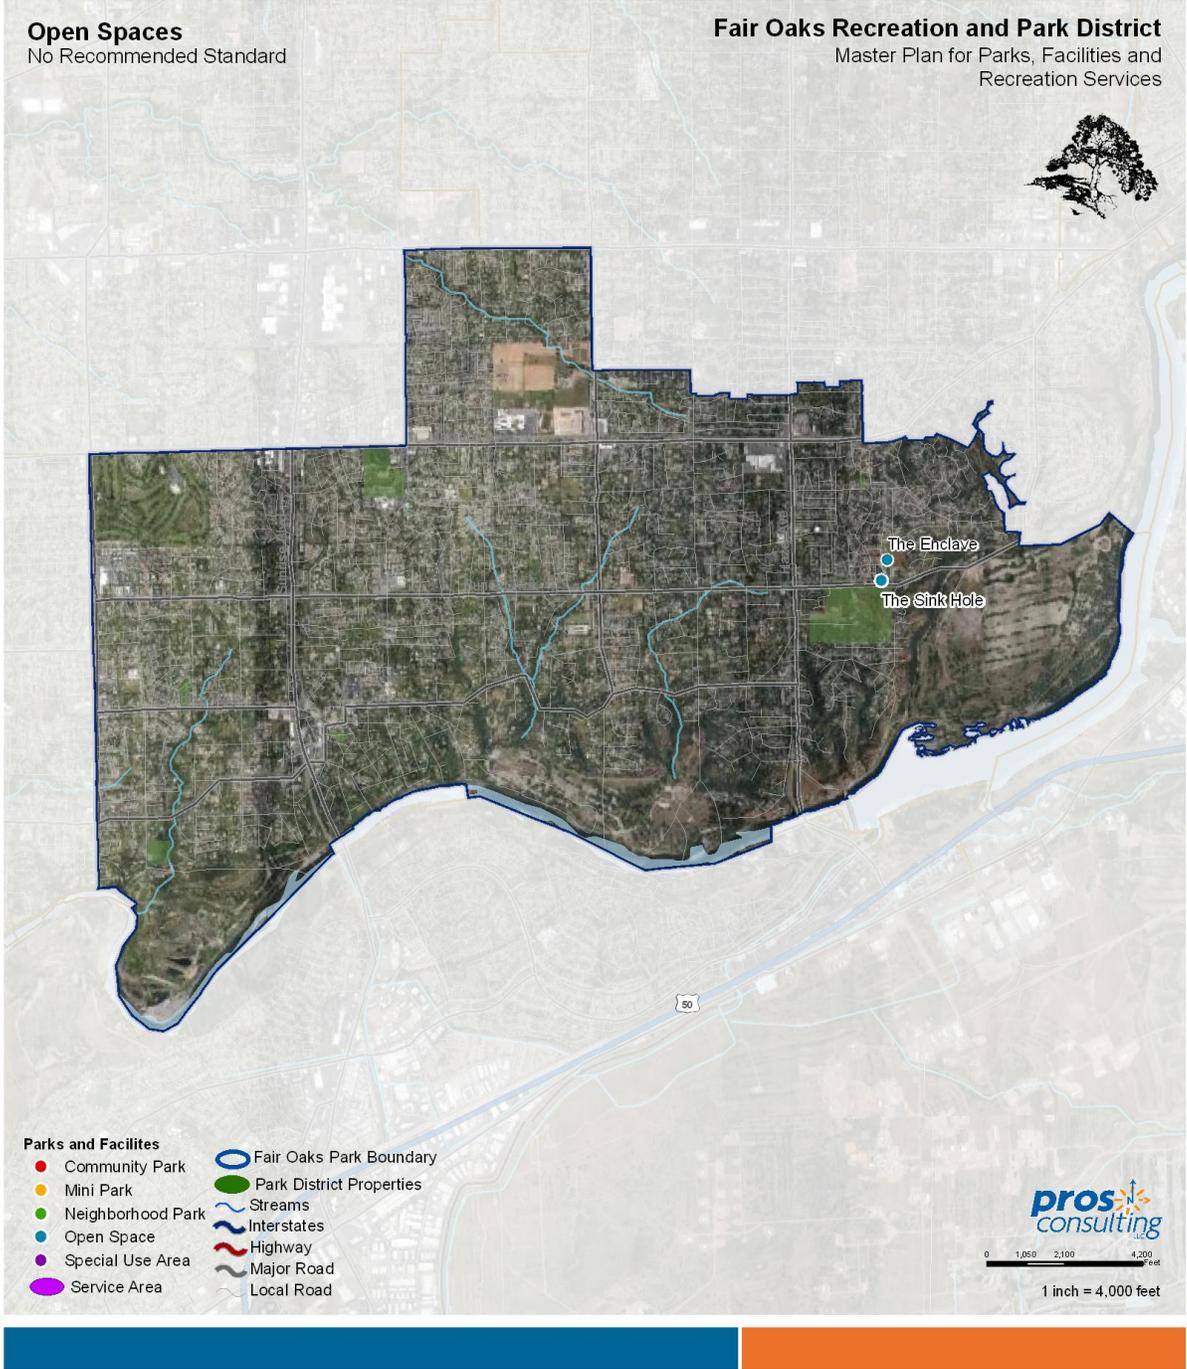
Figure 71 - Open Space Service Area

Figure 71 demonstrates the location of open space areas in the Fair Oaks service area and the associated population densities. The District has 1.04 acres of open space areas. This correlates to a current service level for open space areas of 0.04 acres per person. There is no recommended service level for open space areas.

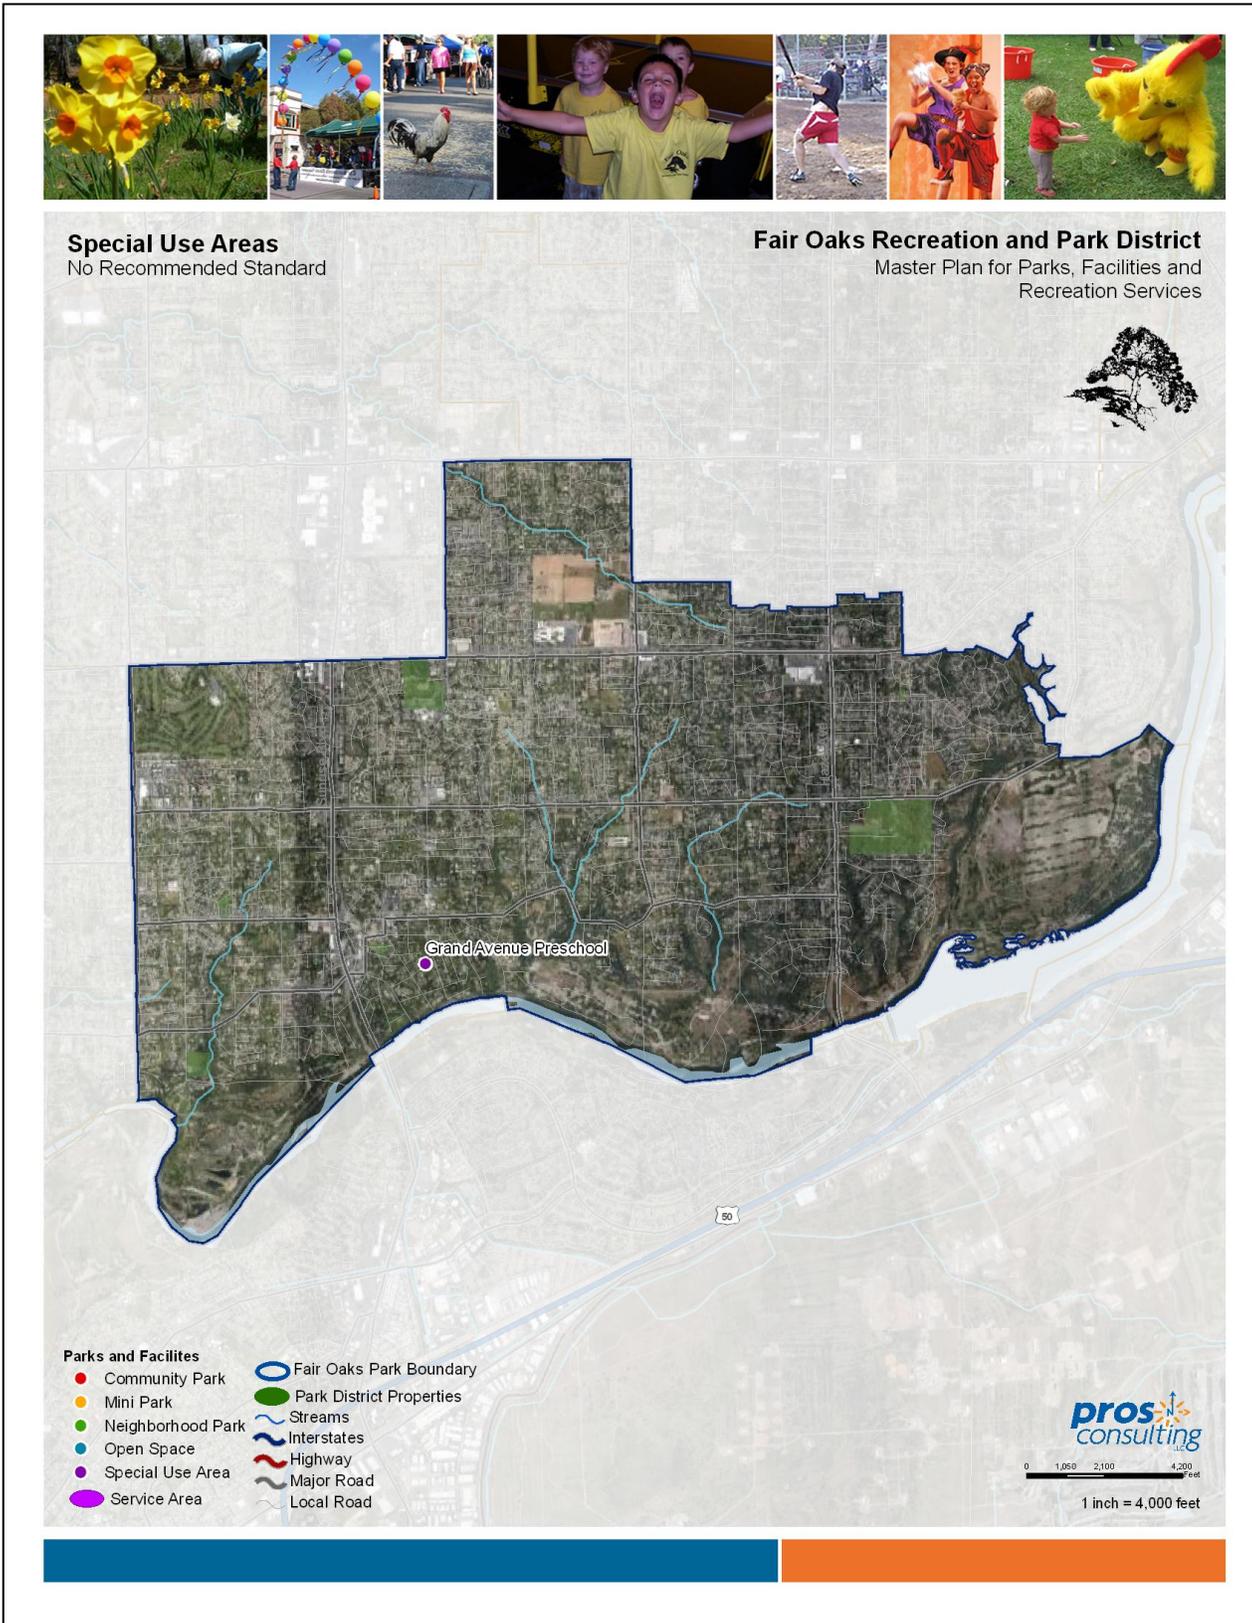
Figure 72 - Special Use Areas Service Area

Figure 72 demonstrates the location of special use areas in the Fair Oaks service area. The District has 0.50 acres of special use areas. This correlates to a current service level for special use areas of 0.02 acres per 1,000 people. There is no recommended service level for special use areas.

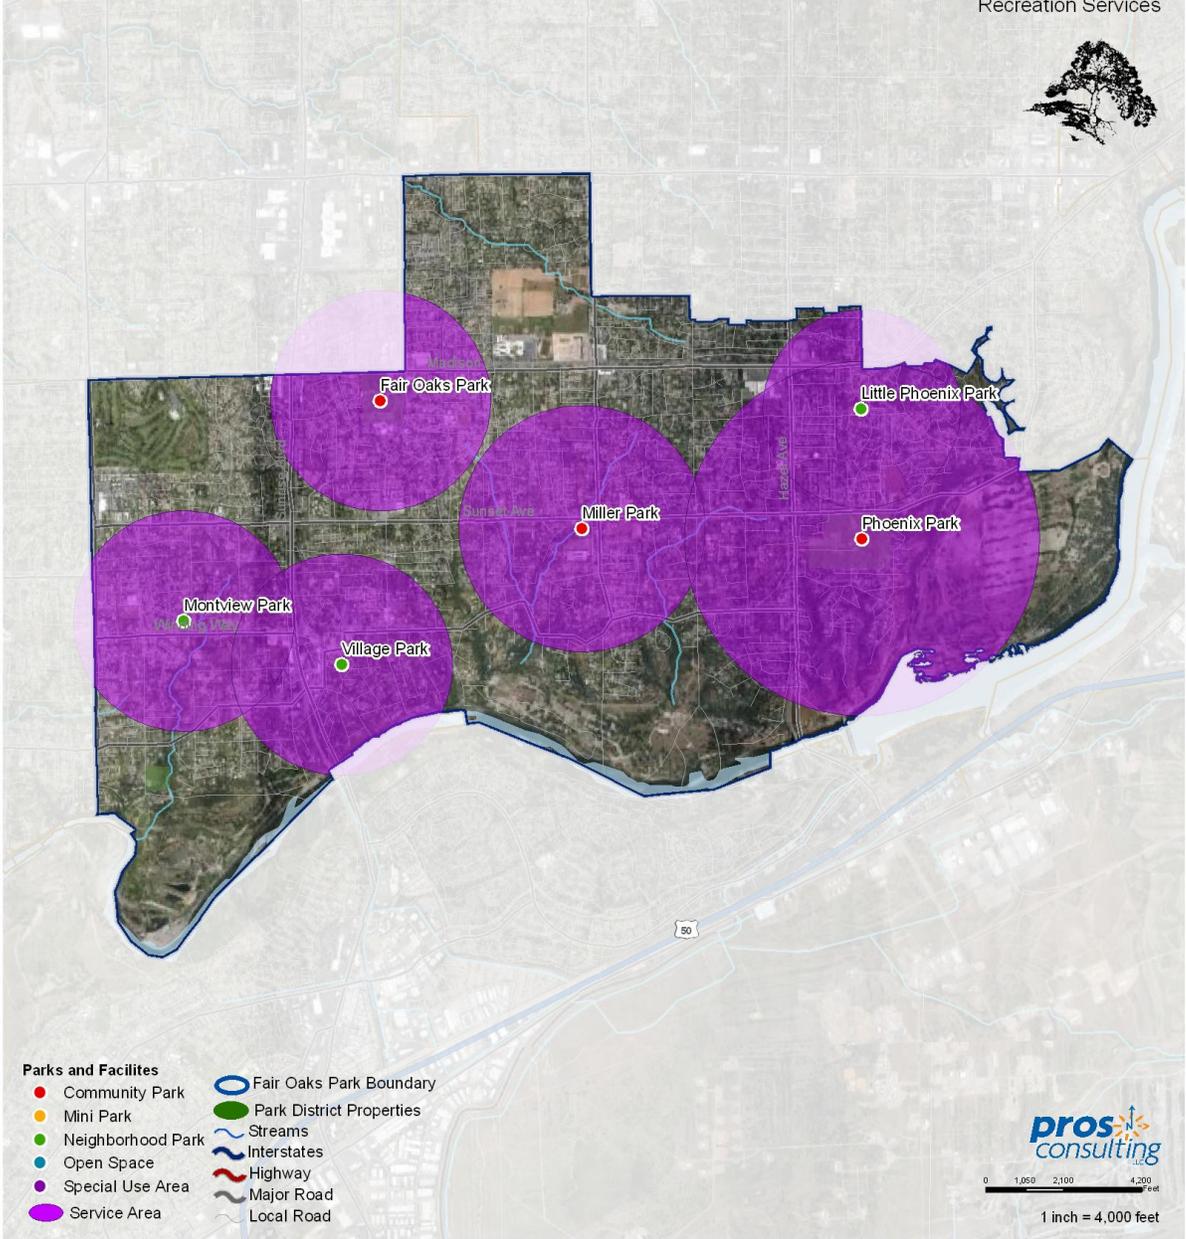
Figure 73 - Playgrounds Service Area

Figure 73 demonstrates the location of playgrounds in the Fair Oaks service area and the associated population densities. The District has 7 playground structures. This correlates to a current service level for shelters of one structure per 4,135 people. This map shows the recommended service level of one structure per 3,000 people. The District does not meet the recommended standard. To meet the 2009 recommended standard, the District will need to add 3 structures. Those three will serve to adequately serve the projected 2019 population. There is currently a need for playgrounds all over the District. There are structures scattered around the District with holes in the north, south, northwest and southwest regions.

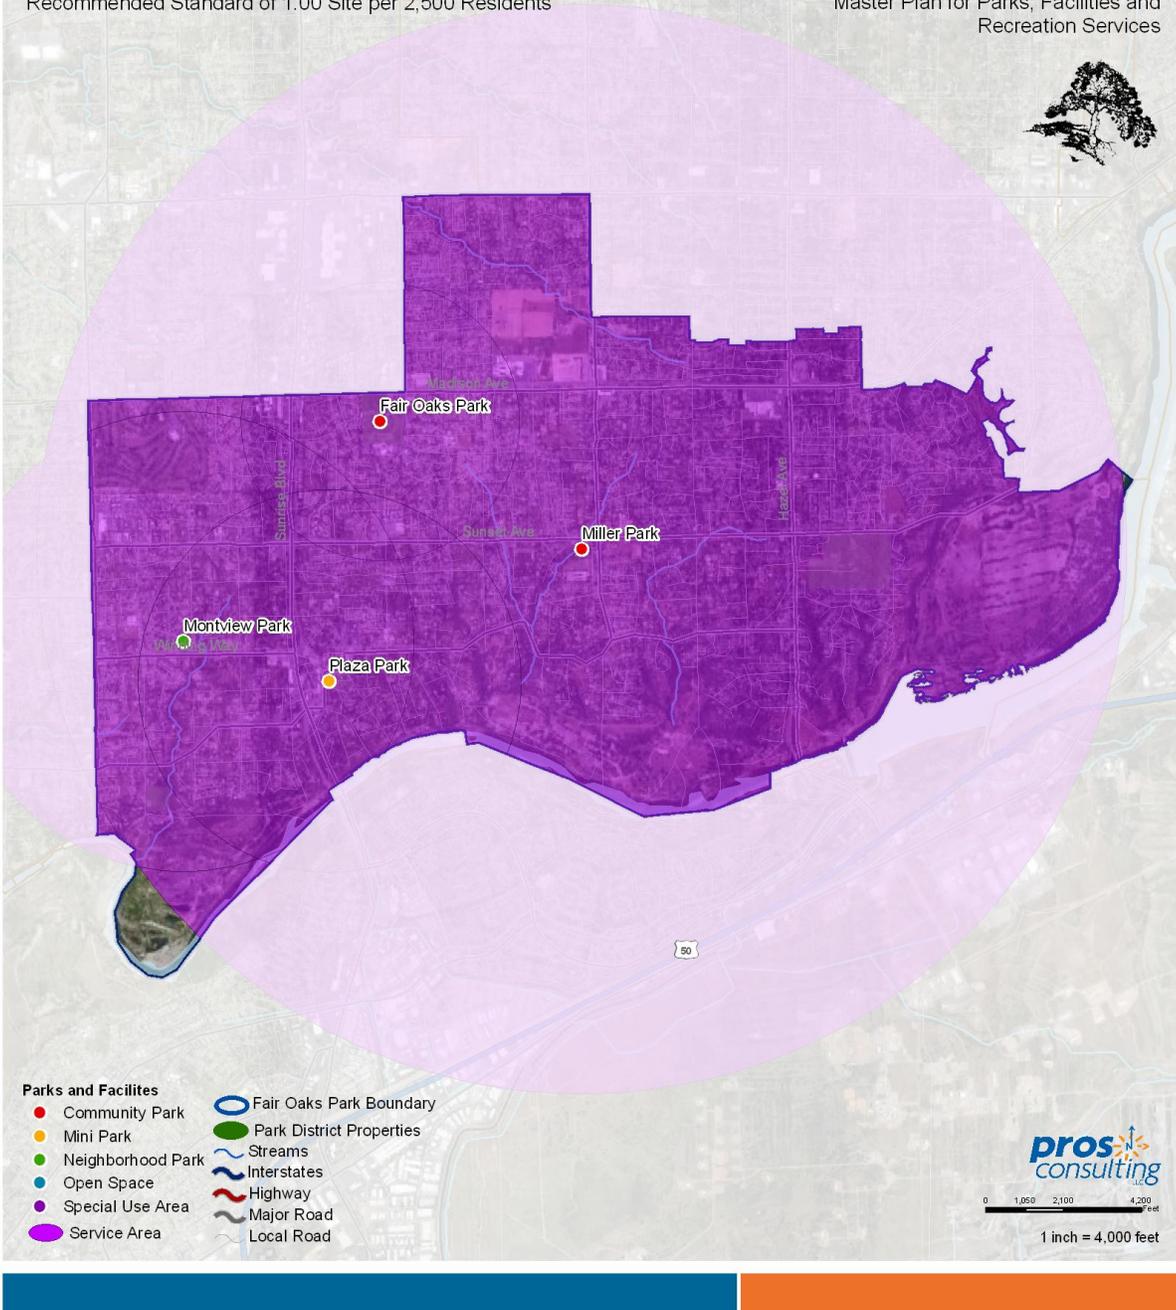
Figure 74 - Picnic Areas Service Area

Figure 74 demonstrates the location of picnic pavilion areas in the Fair Oaks service area and the associated population densities. The District has 21 picnic pavilion areas. This correlates to a current service level for 1 picnic areas per 1,378 people. This map shows the recommended service level of one picnic pavilion area per 2,500 people. The District meets the current and projected recommended standards. Currently there is a need for additional service in the southwestern most corner of the District as the only pavilion is in the north central region.

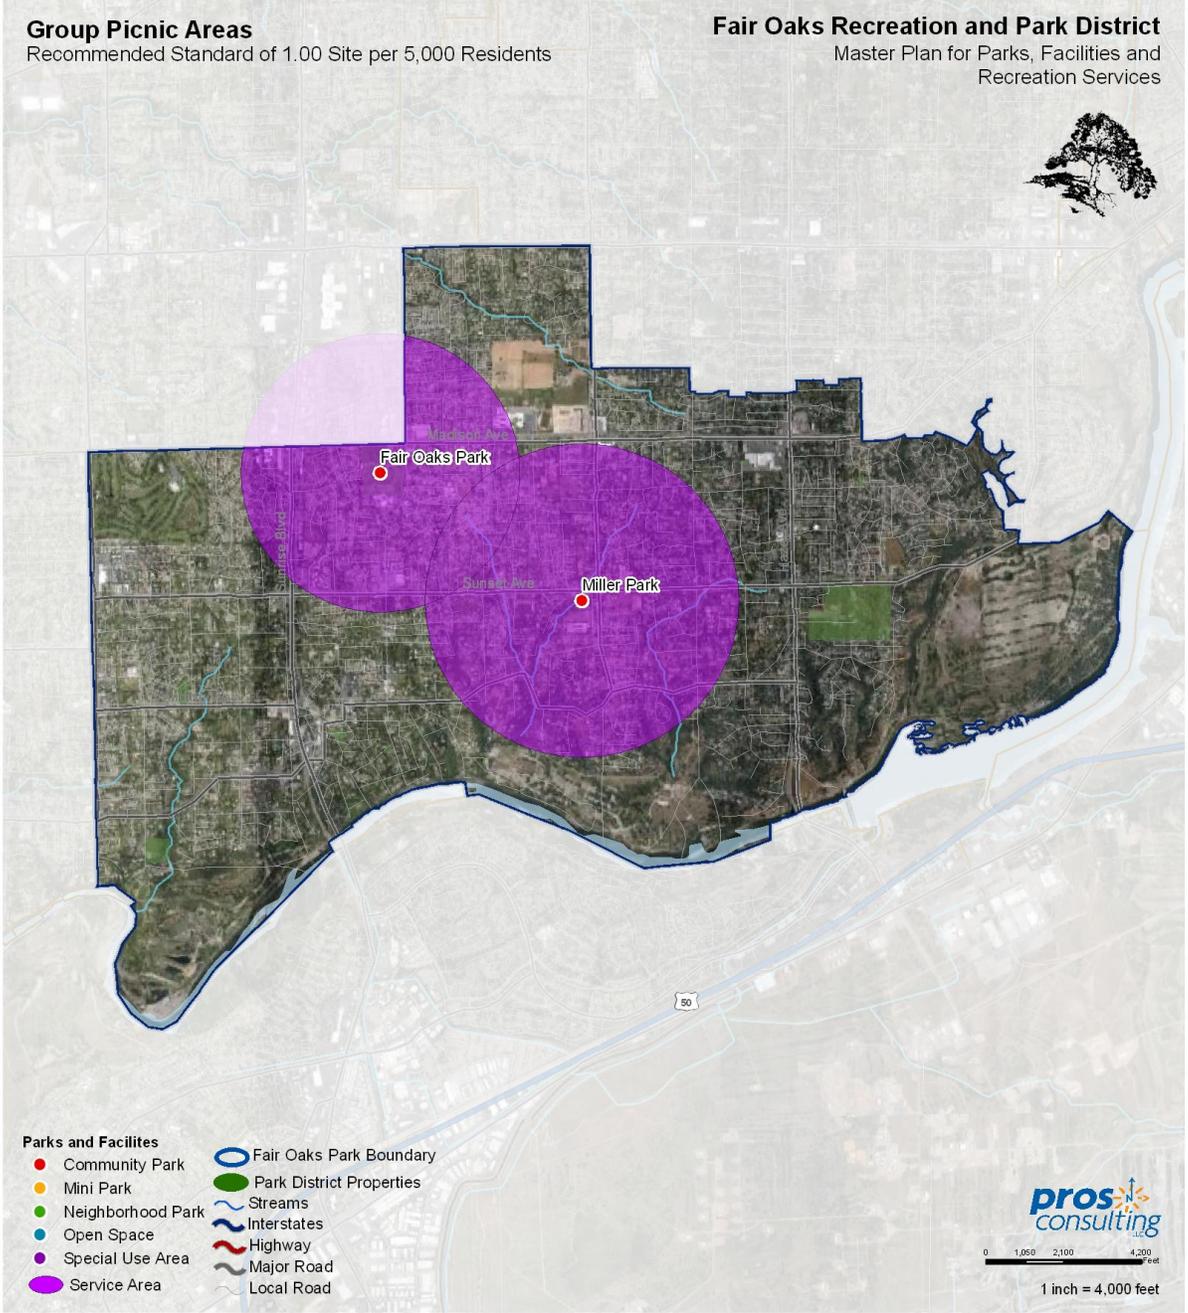
Figure 75 - Group Picnic Areas Service Area

Figure 75 demonstrates the location of group picnic areas in the Fair Oaks service area and the associated population densities. The District has 2 group picnic areas. This correlates to a current service level for group picnic areas of one structure per 14,474 people. This map shows the recommended service level of one structure per 5,000 people. The District does not meet the recommended standard. To meet the 2009 recommended standard, the District will need to add 4 sites and 2 additional sites to serve the projected 2019 population, for a cumulative total of 4 additional sites. There is a need for additional service in the eastern and western regions of the District.

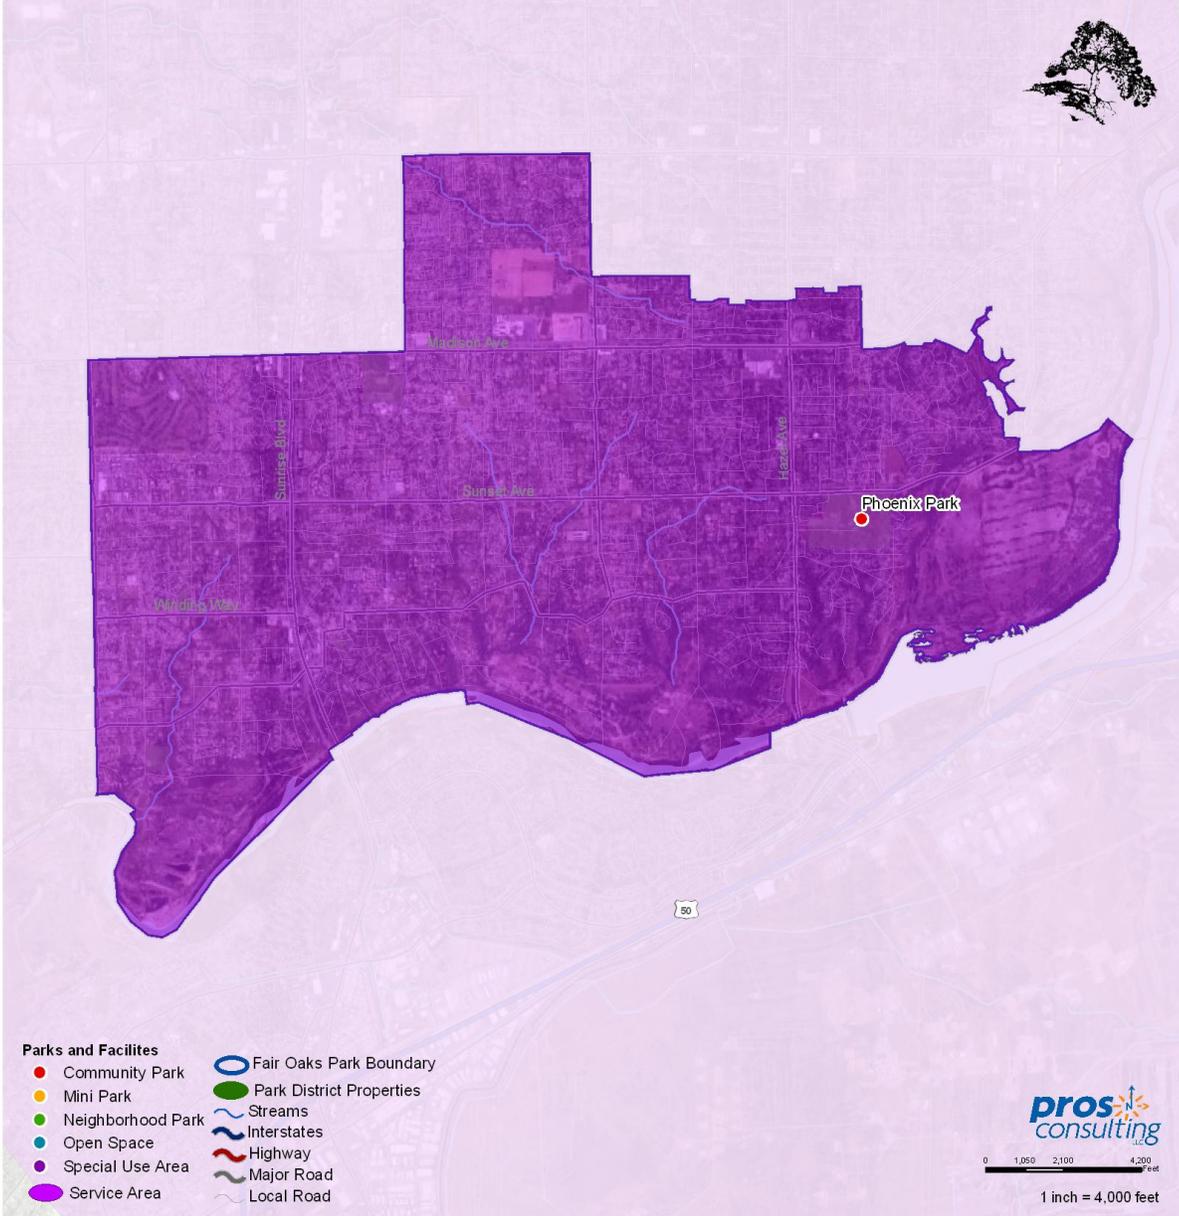
Figure 76 - Diamond Fields - Small Service Area

Figure 76 demonstrates the location of Small Diamond Fields in the Fair Oaks service area and the associated population densities. The District has 3.00 small diamond fields. This correlates to a current service level for small diamond fields of one per 9,649 people. This map shows the recommended service level of one per 10,000 people. The District meets the recommended current and projected standards. There is no need for service as the entire District is well covered.

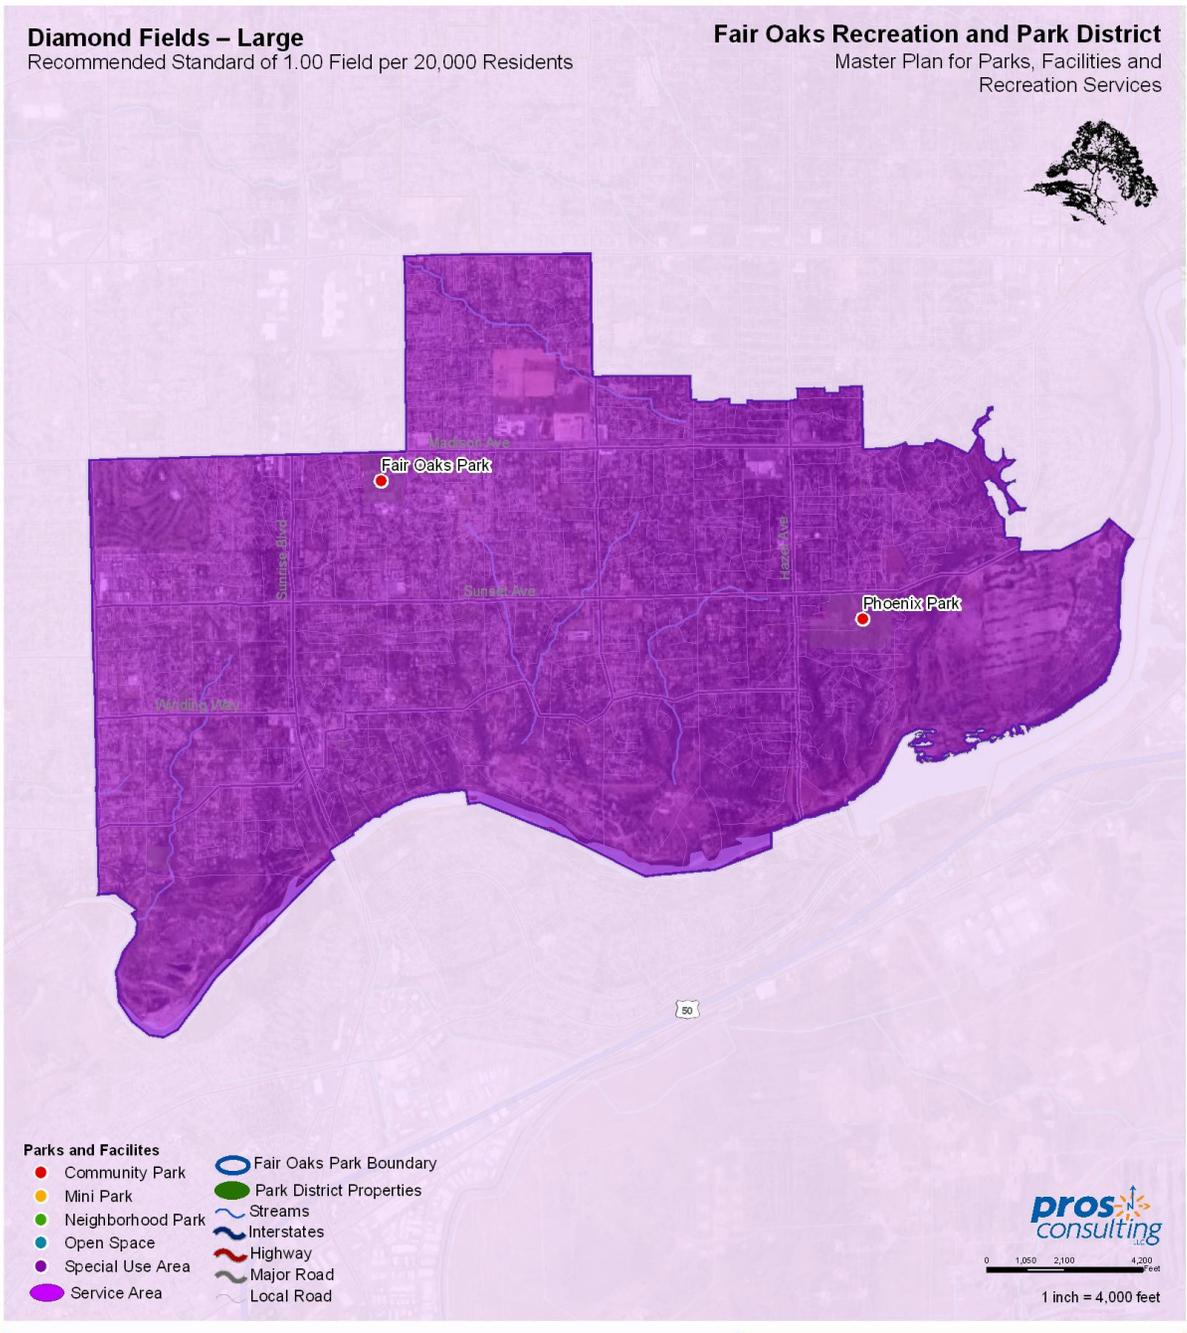
Figure 77 - Diamond Fields - Large Service Area

Figure 77 demonstrates the location of large diamond fields in the Fair Oaks service area and the associated population densities. The District has 4.00 large diamond fields. This correlates to a current service level for special use areas of 1.00 acres per 7,237 people. This map shows the recommended service level of one per 20,000 people. The District

meets the recommended current and projected standards. There is no need for service as the entire District is well covered.
