CHAPTER FOUR - PARKS AND RECREATION ASSESSMENT

4.1 PARK AND FACILITY ASSESSMENT

Fair Oaks Recreation and Park District

Master Plan for Parks, Facilities and Recreation Services

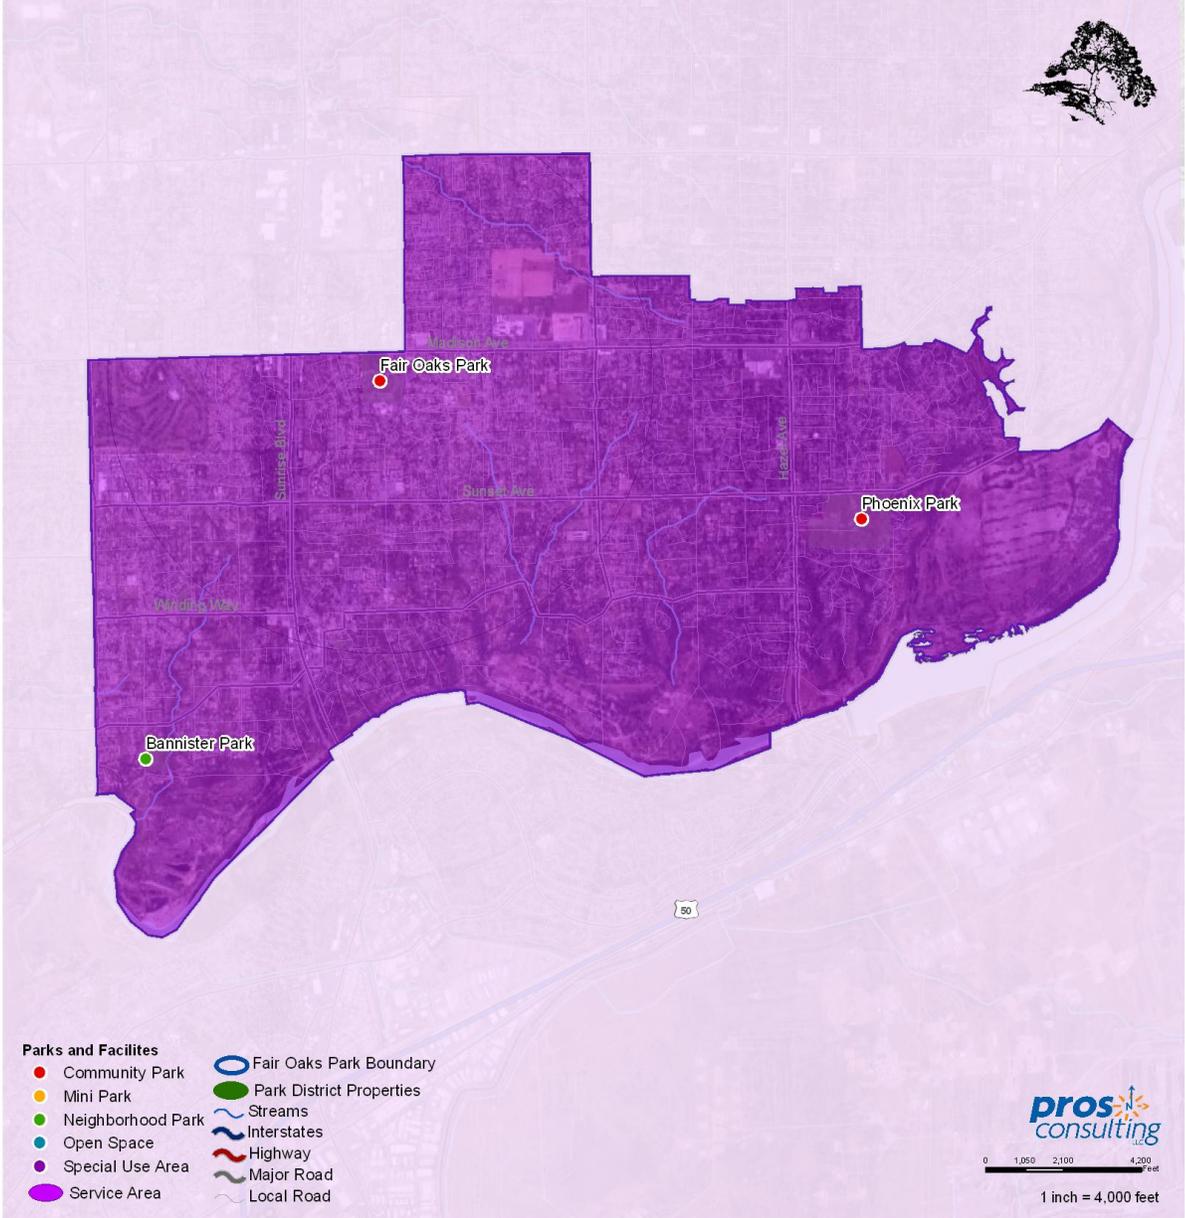
Figure 78 - Multipurpose Fields - Large Service Area

Figure 78 demonstrates the location of large multipurpose fields in the Fair Oaks service area and the associated population densities. The District has 6 large multipurpose fields. This correlates to a current service level for large multipurpose fields of one field per 4,825 people. This map shows the recommended service level of one field per 15,000 people. The District meets the recommended current and projected standards. Currently there is no need for additional service in the District.

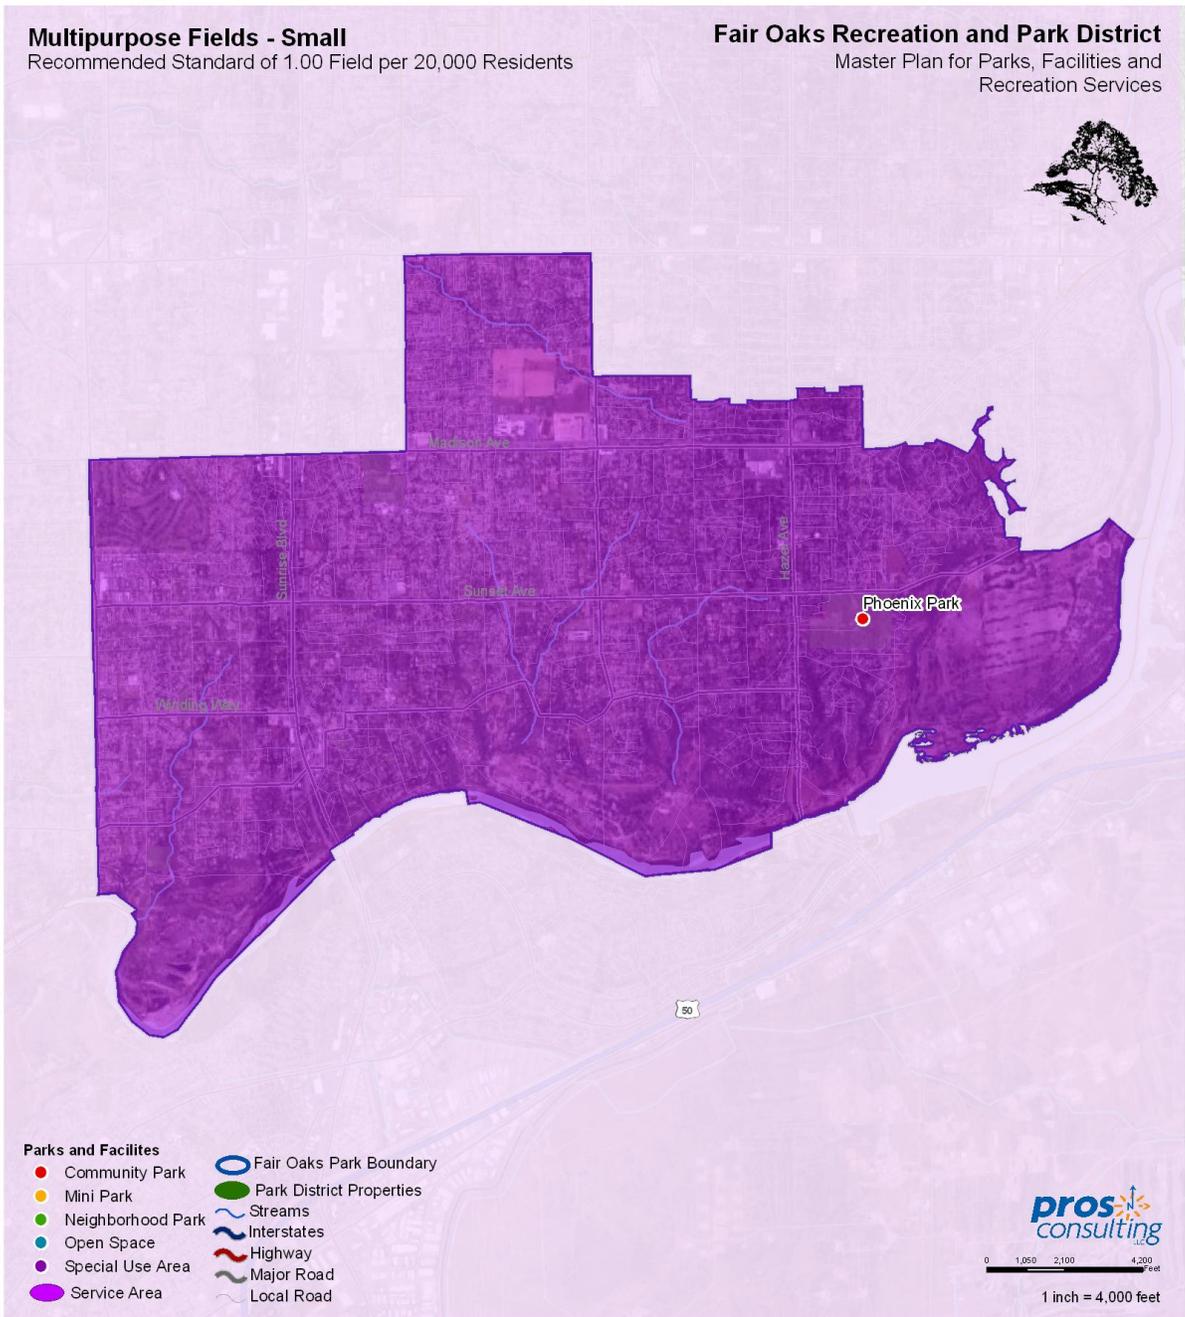
Figure 79 - Multipurpose Fields - Small Service Area

Figure 79 demonstrates the location of small multipurpose fields in the Fair Oaks service area and the associated population densities. The District has 3 small multipurpose fields. This correlates to a current service level for small multipurpose fields of one field per 9,649 people. This map shows the recommended service level of one field per 10,000 people. The District meets the recommended current and projected standards. Currently there is no need for additional service in the District.

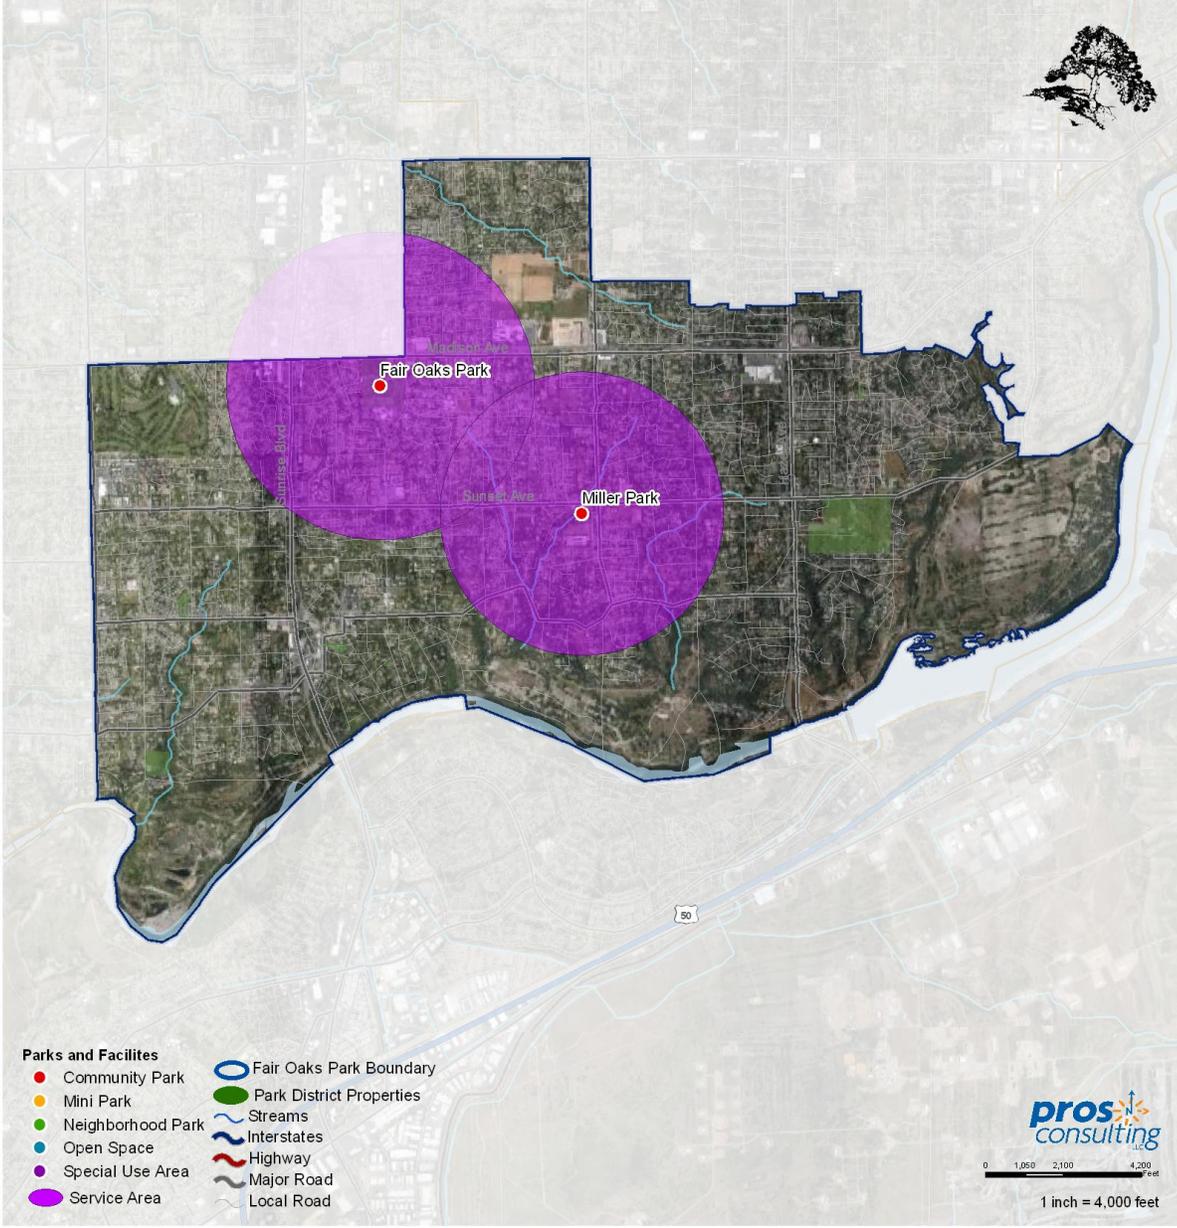
Figure 80 - Basketball Courts Service Area

Figure 80 demonstrates the location of basketball courts in the Fair Oaks service area and the associated population densities. The District has 2.5 basketball courts. This correlates to a current service level for basketball courts of one court per 11,579 people. This map shows the recommended service level of one court per 4,000 people. The District does not meet the recommended standard. To meet the current standards and the standards for the 2019 population, the District needs to add five basketball courts. There is currently a need for service in the majority of the District as the existing basketball courts are in the center of the District.
